MEMORANDUM  
INTERMOUNTAIN POWER SERVICE CORPORATION  
INTERMOUNTAIN GENERATING STATION

SUBJECT: Follow up Report Concerning the Cooling Tower Fan Blade Resonance and Ceramic Cooling Towers Proposed use of a Ten Blade Fan System

REFERENCE: Letter, dated January 29, 1987, Resonance of Cooling Tower Fan Blades may be causing fan failures.

## Fan failures traced to blade resonance excitation by the innovative use of instrumentation

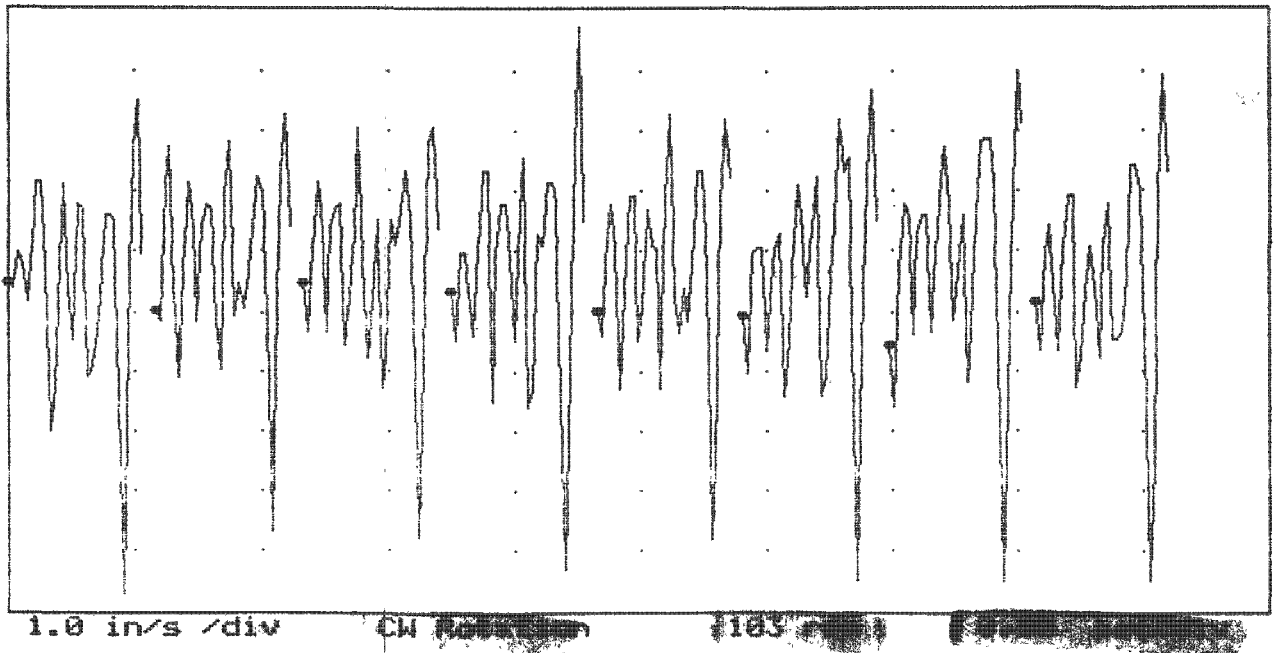
Machine: Cooling Tower Fan CH# 1 Blade # 1  
16 OCT 87 08:23:29.8 Steady State UNCOMP

Figure 4 shows 21 samples of the running data taken at 10 second intervals. Since the Keyphasor signal was recorded simultaneously with the accelerometer signal, this plot was labeled in terms of multiples of running speed, commonly referred to as "X" (e.g. 1X, 2X, etc.). The data taken at 08:23:29 was selected as being typical of the average of the 21 spectrums (Figure 5). This plot indicates a high 4X component which was found to be related to the fan cell design.

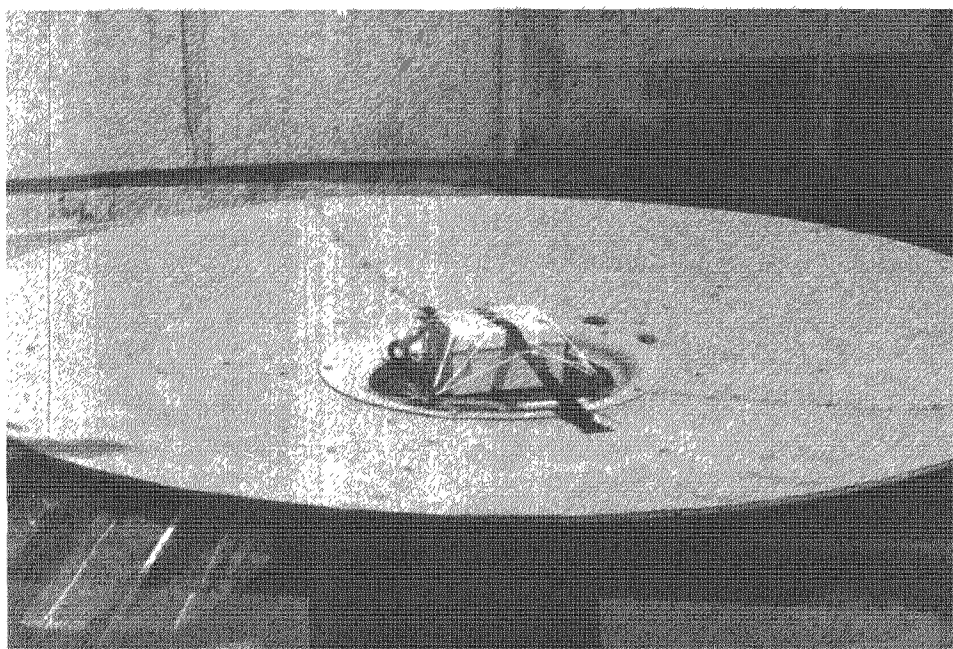
PICTURE # 5

The data gathered first was the result of a fan static condition, while air was short circuited through the dormant cell. As attachment 1 indicates the three blades were being excited at natural blade resonance, 412 cpm. Attachment two indicates the signal waveform of the three blades as the fan was in operation. The waveforms have been integrated from acceleration to velocity with the ADRE 3 Data Acquisition System. All values indicated in these plots should be multiplied by a factor of 10. Attachment 2 indicates very clearly that each blade was being excited four times during each revolution. Other minor spikes in the waveform indicate reaction to other blades moving in the fan system, thus creating a fan hub wobble. Signature traces, cascade plots, and careful attention to the key phase reference mark in attachments 3 - 6, bear this last comment out. The probe on blade # 5 was damaged shortly into the test, so data was not available.

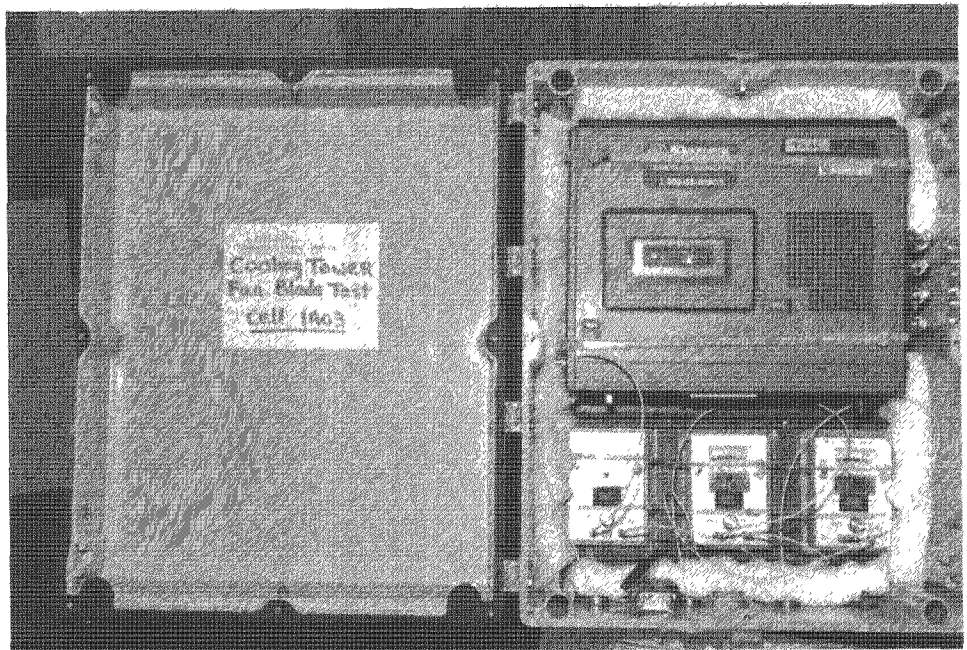
PICTURE # 2

Fan cell 1A03 was selected for this special vibration test because of several tripping problems due to a blade droop switch being activated. Acceleration probes were mounted at the end of three of the seven blades, (see picture #1). A cable was then run from the probe to a recorder and power system, which were mounted in the center of the fan hub, (see pictures 2 thur 5). A key phaser was also attached to the fan hub and referenced to a point on the gear reducer. With this unique setup, vibration data concerning the blade movement could be obtained while the fan was in operation.
